# Volkswagen

VIN: WV1ZZZ7HZKH050653

2019

Generat pe 2025-01-14 15:41

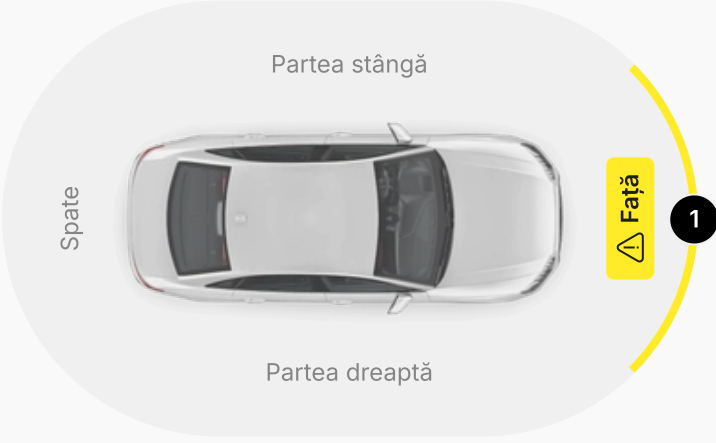
2022-01

**Față**

**2.001 RON – 6.000 RON**

**Necunoscut**

**Sticlă**

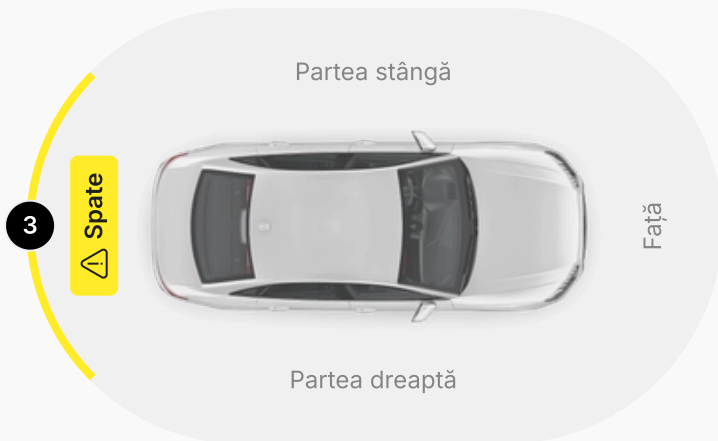
Daune pe partea dreaptă:

Spate / Bară de protecție

Spate stânga / Bară de protecție

Spate dreapta / Bară de protecție

2022-07

Spate

**2.001 RON – 6.000 RON**

Părți exterioare ale caroseriei
